**CULTURAL PROPERTIES RESTORATION FUND GRANT PROGRAM
APPLICATION CHECKLIST – FORM 01 of 12**

PROJECT NAME: Bataan Memorial Building – Interior Rehabilitation

APPLICANT: State of New Mexico, General Services Department

**CULTURAL PROPERTIES RESTORATION FUND GRANT PROGRAM
SCOPE OF WORK / DAMAGE, DETERIORATION & THREAT FORM /
PROFESSIONAL EXPERTISE – FORM 03 of 12**

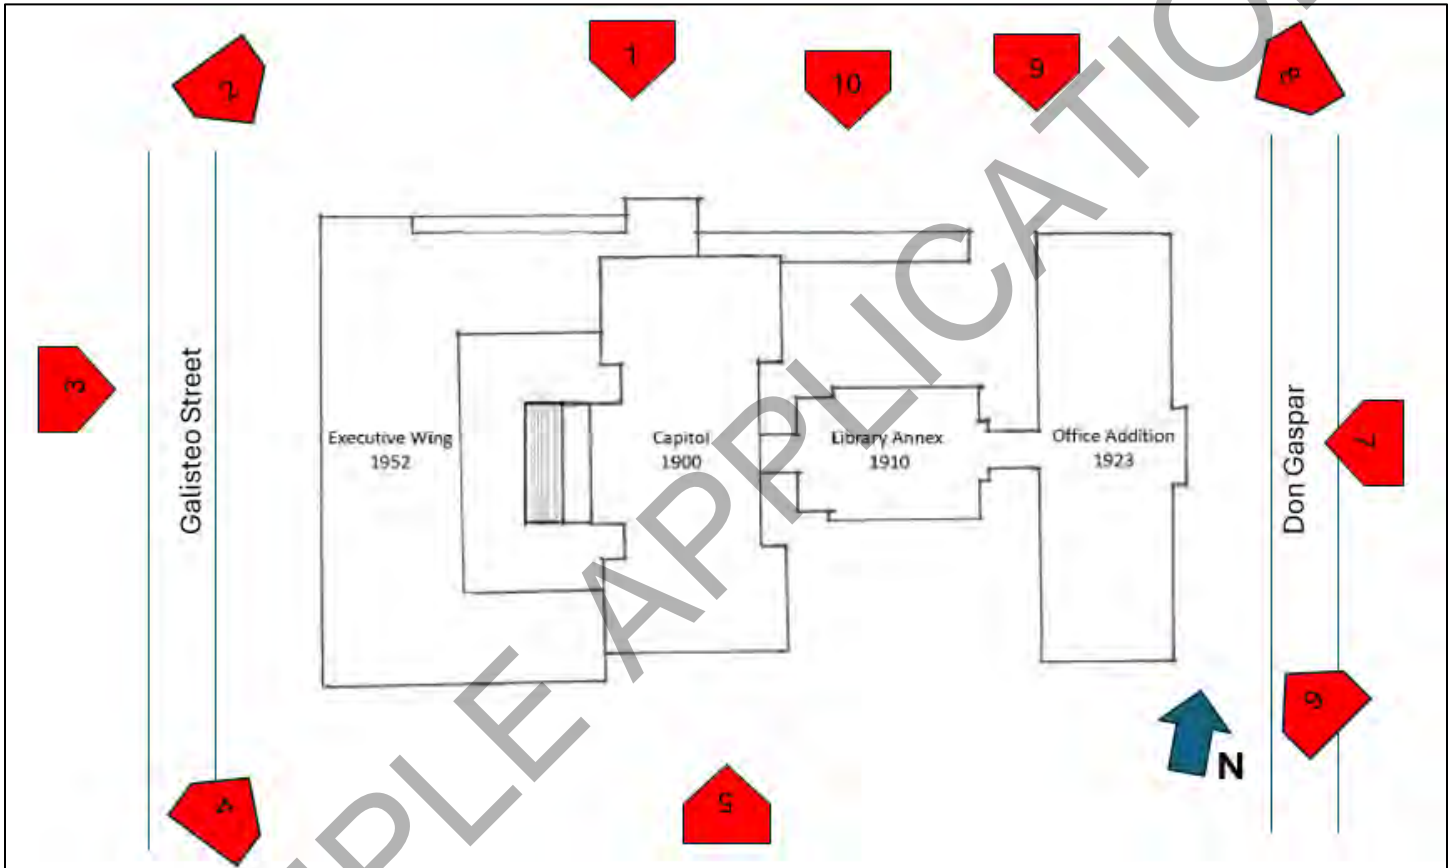
Keyed plan with locations of exterior photographs – numbers correspond to the numbered photograph following.

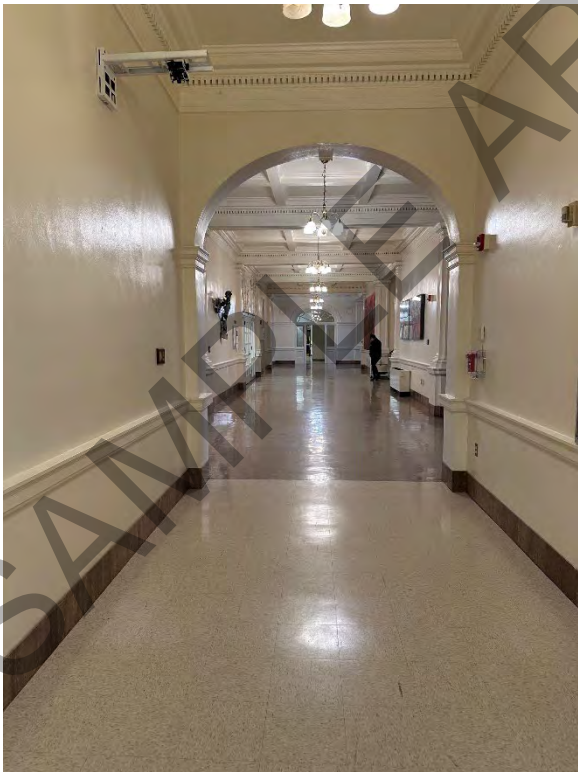
Second floor of the Bataan Building
Image 24 (above, left) – Detail of terrazzo flooring in 1900 building section
Image 25 (above, right) –Detail of stairs in 1900 building
Image 26 (below, left) –Looking east
Image 27 (below, right) –Looking east

A second contractor will remove the linoleum covering the terrazzo flooring and repair and rehabilitate the terrazzo flooring underneath. The flooring is currently located in the 1900 building section and the project will only include this area of flooring. 220 words

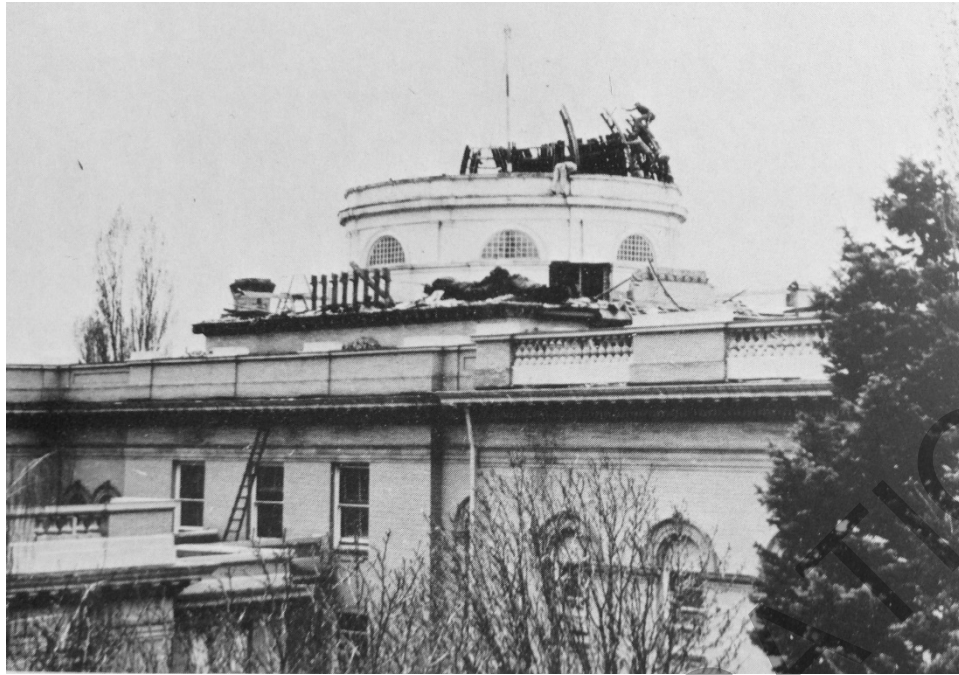
Image 41 (above) – Historic photograph (no date) of removal of dome
Image 42 (below) – View of current dome protective cover, photo looking south

The project also includes the installation of two skylights on the dome roof. The skylights will provide much-needed daylight to backlight the rosette window after its rehabilitation and repair. The two skylights will be installed on the flat dome roof and will not be visible due to the parapet walls.

Related to the rosette window and the flooring project, GSD will annually inspect the rosette window and the protective dome structure above it. In addition, GSD will ensure that cleaning staff do not use harsh cleaning chemicals on the restored terrazzo flooring. The flooring will be inspected annually to ensure care of the terrazzo flooring continues, repairs will be made, as needed. GSD will work closely with HPD should changes be required for these two areas in the future.
